Eurasian water-milfoil (*Myriophyllum spicatum*)
Late Summer Bed Mapping Survey
Osprey Lake (WBIC: 2395100)
Sawyer County, Wisconsin

Endangered Resource Services, LLC
Matthew S. Berg, Research Biologist
Saint Croix Falls, Wisconsin
September 5, 2020

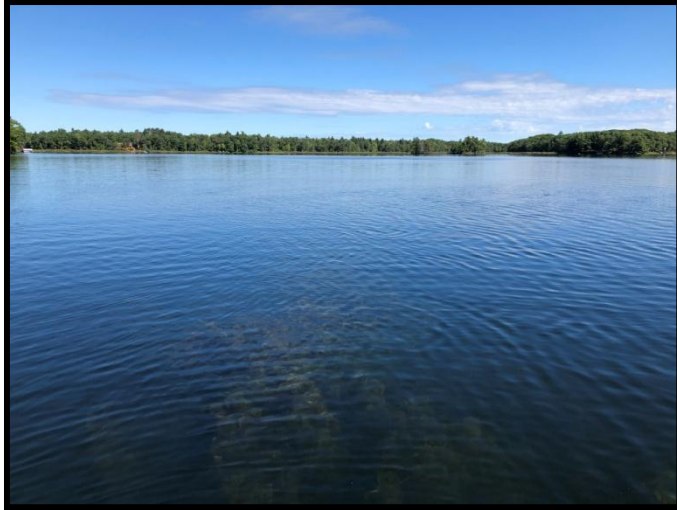
EWM beds (red)/High density areas (yellow)

Dense canopied EWM in Bed 1 on the south end of the main basin 9/5/20
