PUBLIC MEETING OSPREY LAKE AQUATIC PLANT MANAGEMENT PLAN

Public Input Meeting, May 16 2026

Public Input Meeting for Osprey Lake Aquatic Plant Management

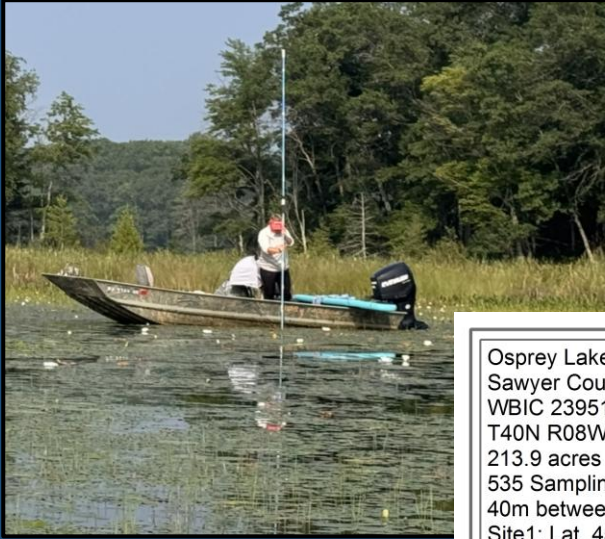
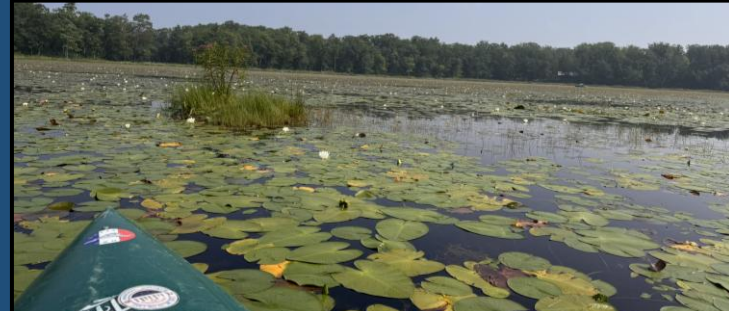
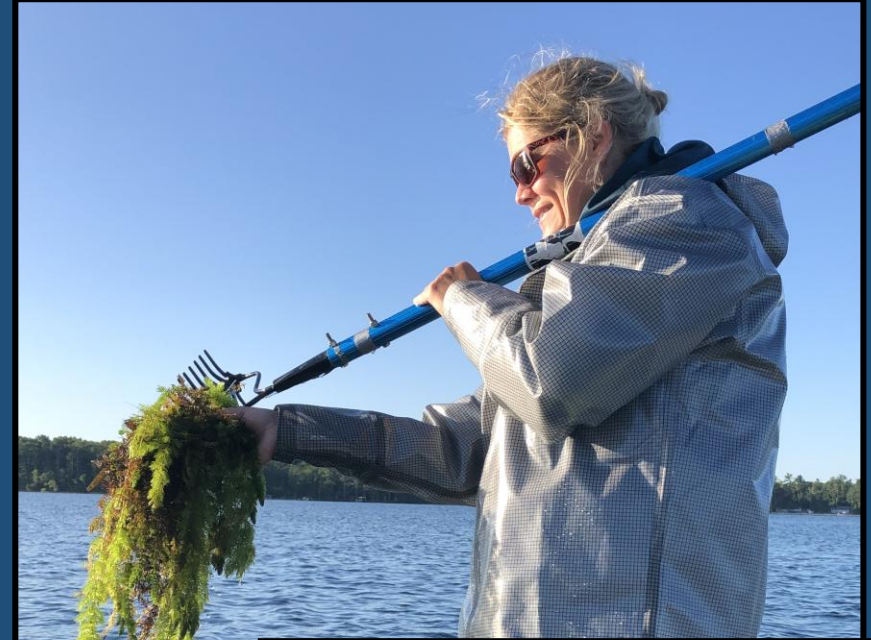
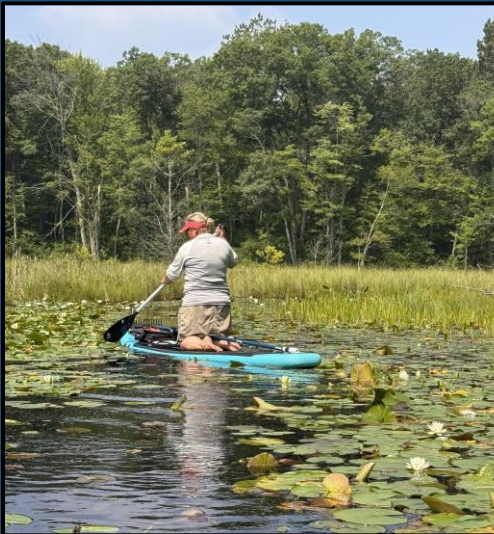
Aquatic Plant Survey Methods

Osprey Lake
Sawyer County
WBIC 2395100
T40N R08W S01
213.9 acres / 86.6 ha
535 Sampling Points
40m between Points
Site1: Lat. 45.97298699
Long. -91.31140866

535 Sample Points!
July 24-25, 2025

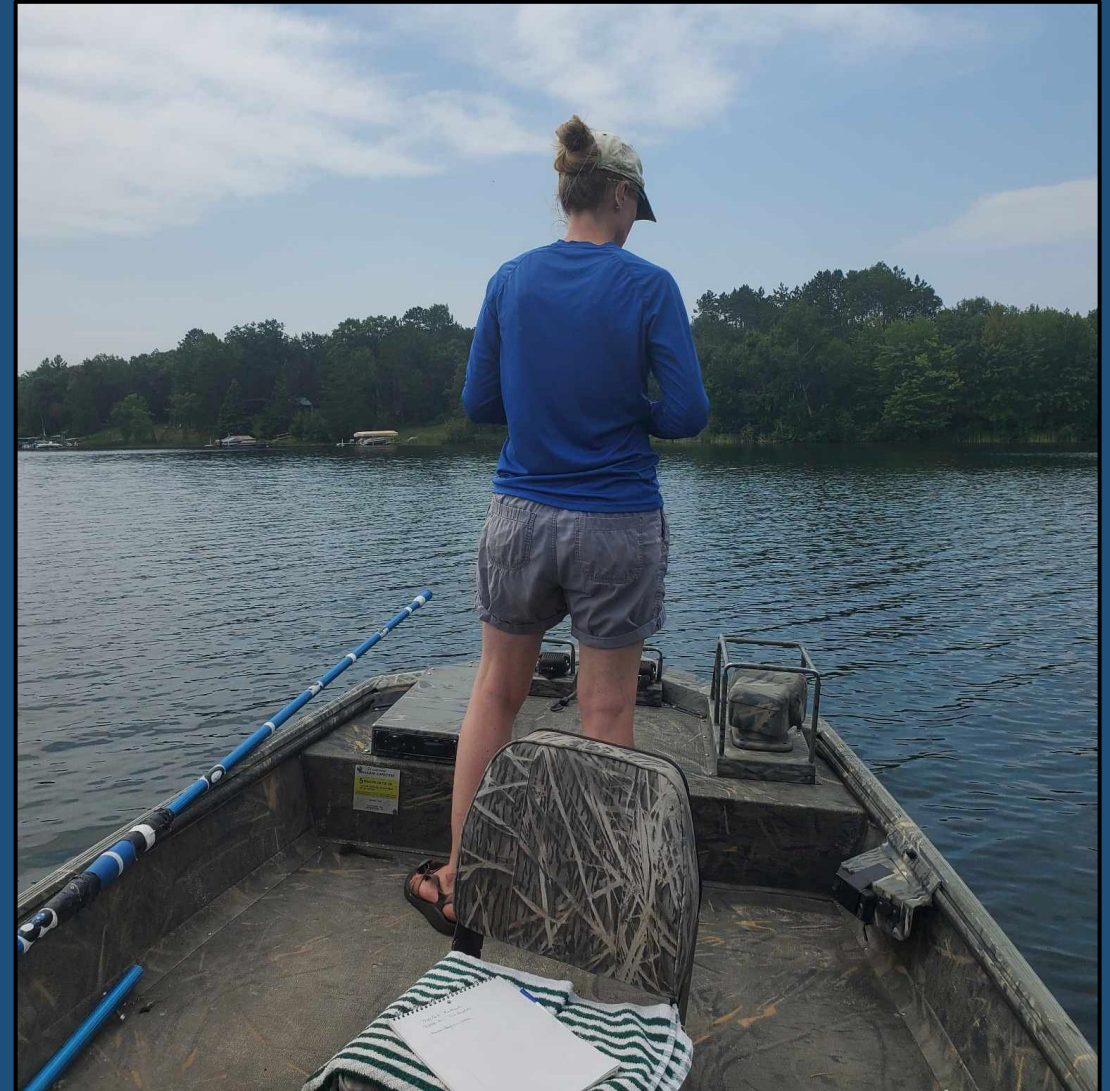
EWM Bed Survey Methods

- Cruise the lake, late Aug – early Sept
- Capture boundaries of EWM beds on GPS device
- Record EWM bed attributes
 - Depth
 - Plant
 - Density

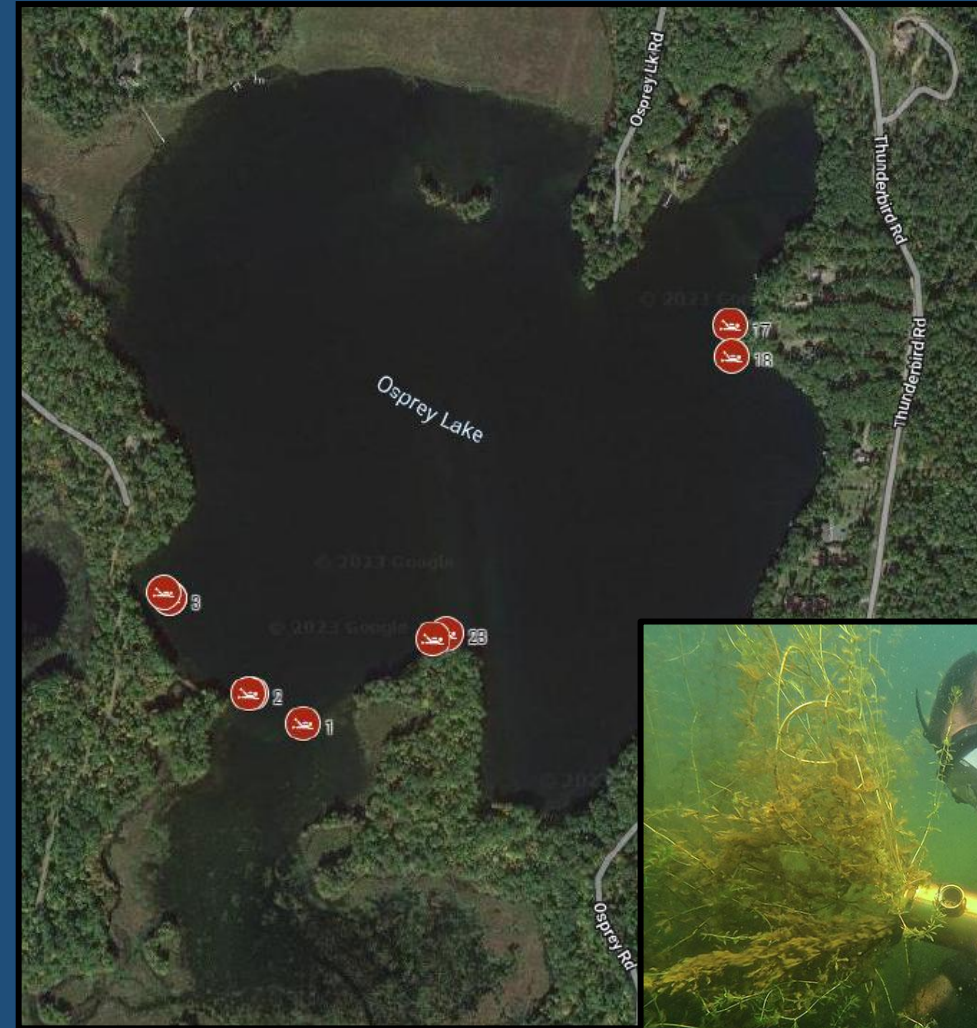
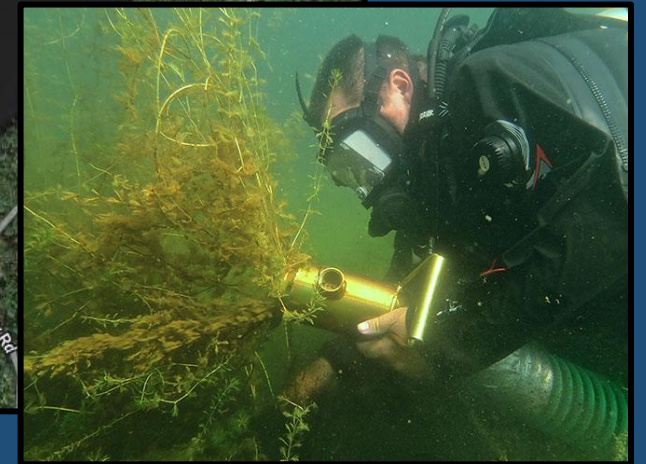
Diver Assisted Suction Harvesting (DASH)

- Uproot vegetation
- Suction tube/pontoon
- Permit required
- Appropriate for small-scale control
- Appropriate following herbicide treatment to increase time interval between herbicide application

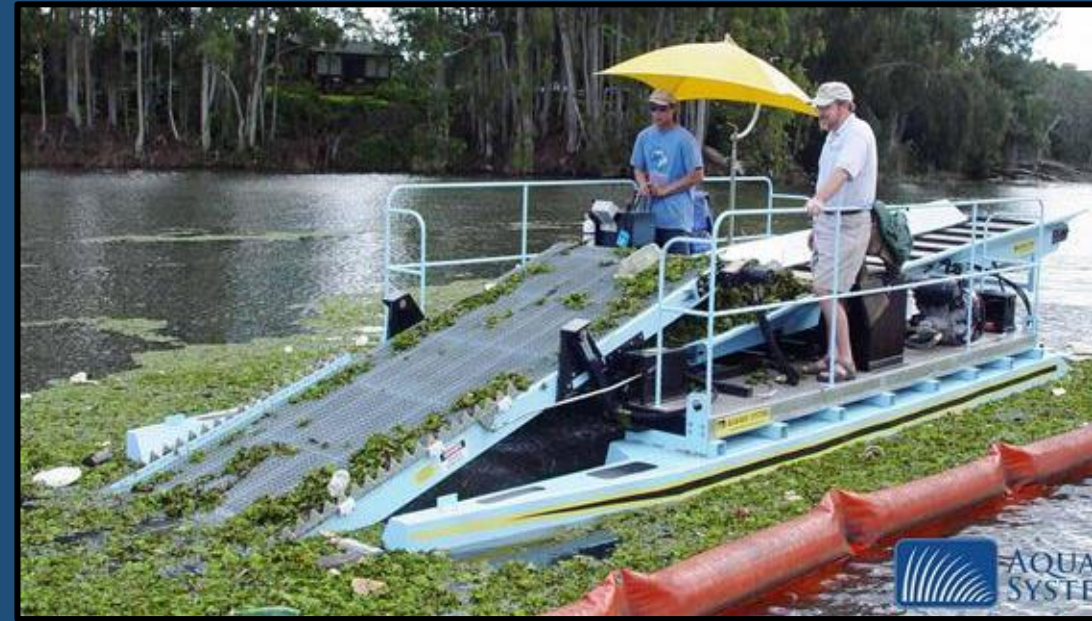
Mechanical Harvest

- Cutting plants down to depth of 5-6 feet
- Permit required
- Concerns associated with impacts to panfish spawning, timing important
- Appropriate for large-scale or lake-wide issues

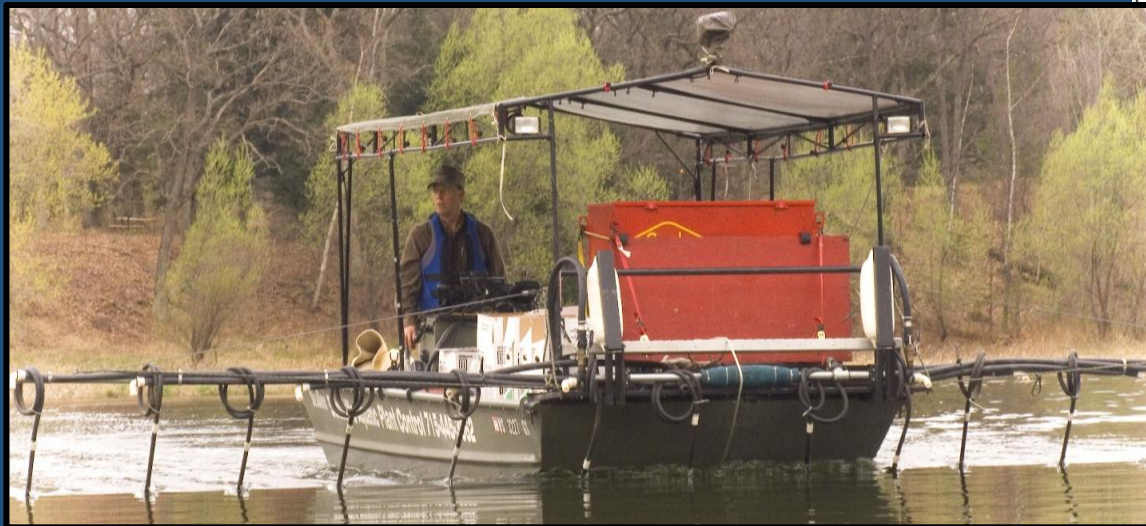
Chemical Control

- Herbicide applied to lake to kill plants
- Permit required
- Larger treatments are more effective, small treatment areas are no longer recommended and last 2 years or less.

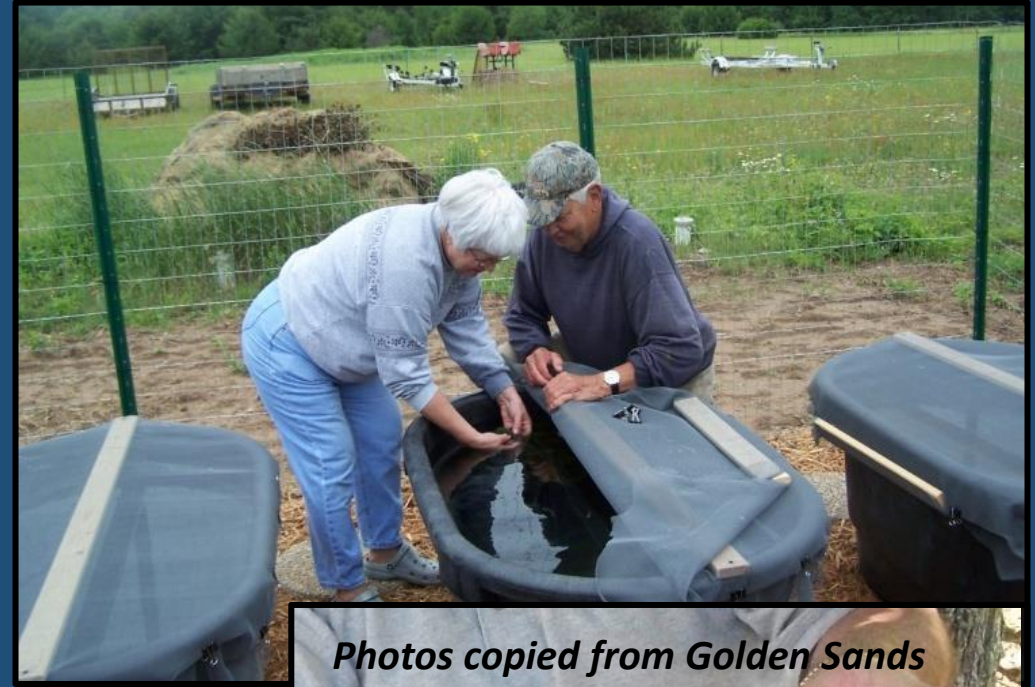
Rearing Weevils

- Rearing tanks with starter stock of weevils
- Feed weevils using “clean” EWM
- Release into beds of EWM
- 6-12 volunteers committed for 3 years

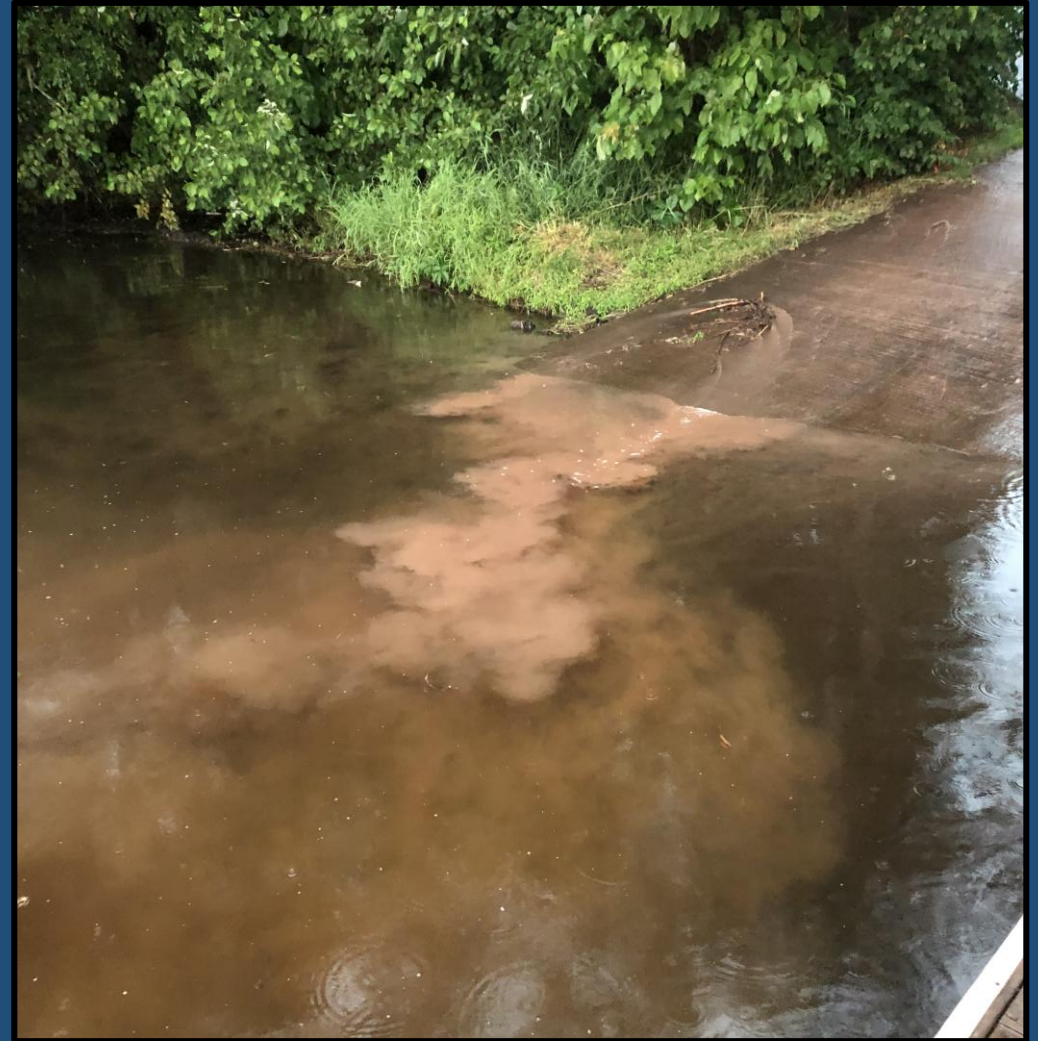
Surface Water Runoff

- Impervious surfaces
 - Buildings, paved surface, decks, compacted gravel sites, etc.
- Precipitation → Runoff
 - Runoff is warmer
 - Warmer water “holds” less dissolved oxygen
 - Runoff carries sand, soil into lake
 - Runoff carries phosphorus into a lake

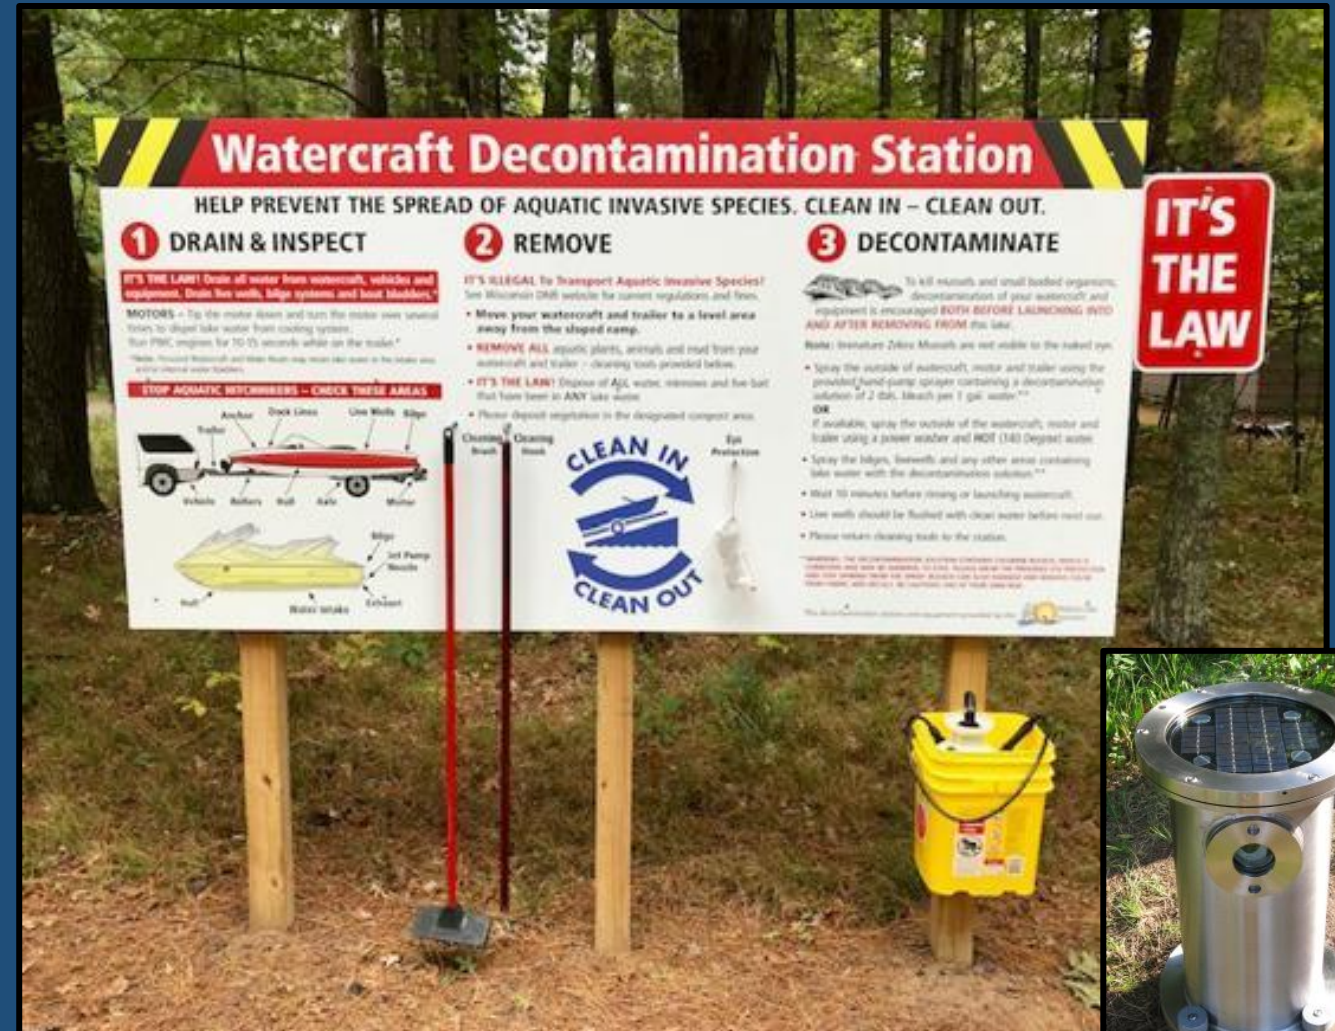
AIS Prevention - Decontamination & ILIDS

- Internet Landing Installed Device Sensor (ILIDS)
 - Motion sensor audio instructs boaters
 - Camera records boater activity
- GRANT ELIGIBLE (AIS Prevention)
 - CBCW program required
