**Eurasian water-milfoil (*Myriophyllum spicatum*)  
Late Summer Bed Mapping Survey  
Osprey Lake (WBIC: 2395100)  
Sawyer County, Wisconsin**

Endangered Resource Services, LLC  
Matthew S. Berg, Research Biologist  
Saint Croix Falls, Wisconsin  
September 1, 2024

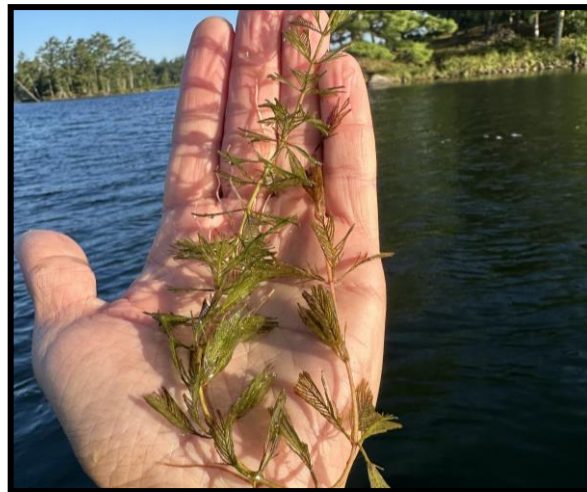
Chemically burned EWM outside the northeast treatment area – 9/1/24
